**National Highway
Traffic Safety
Administration**

Case Status Report

Case # 009

Accident Summary: Veh. 1 driving on 4-lane undivided roadway overreacted
to vehicle entering traffic lane swerved to right and contacted a wooden
utility pole. Airbag deployed causing driver 1 eyeglass frame to slice left
eyeglobe.

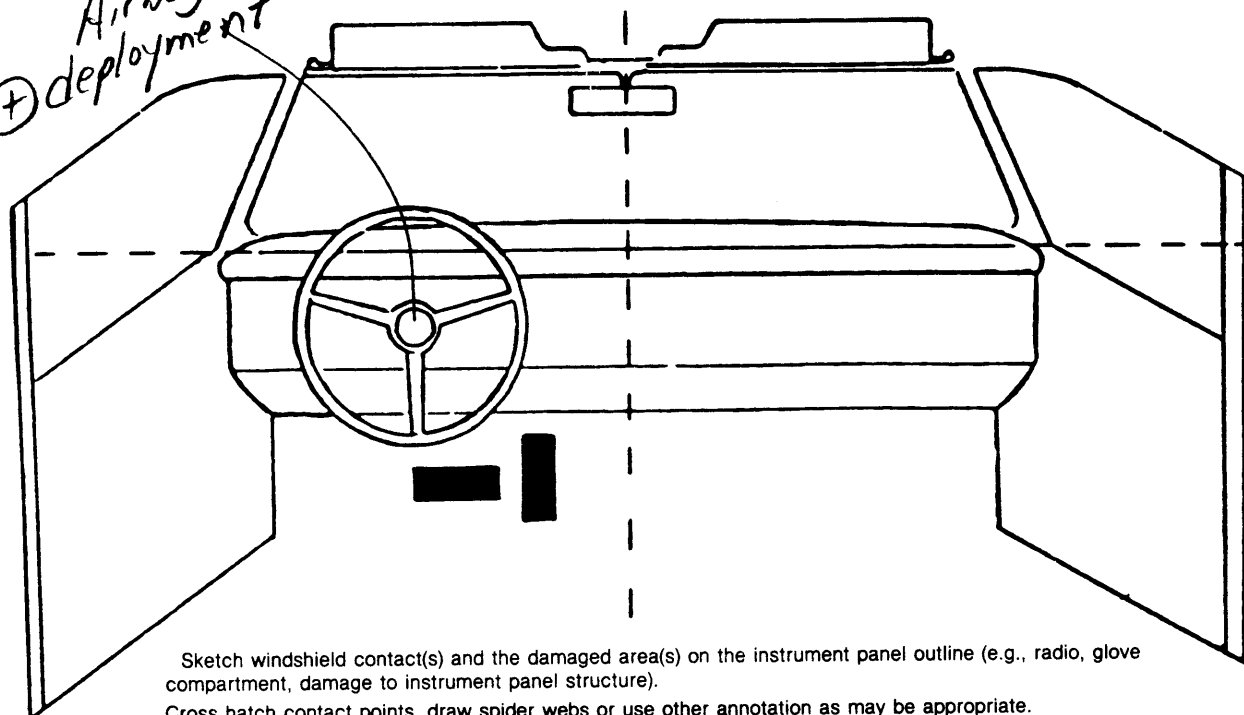
⊕ Airbag deployment

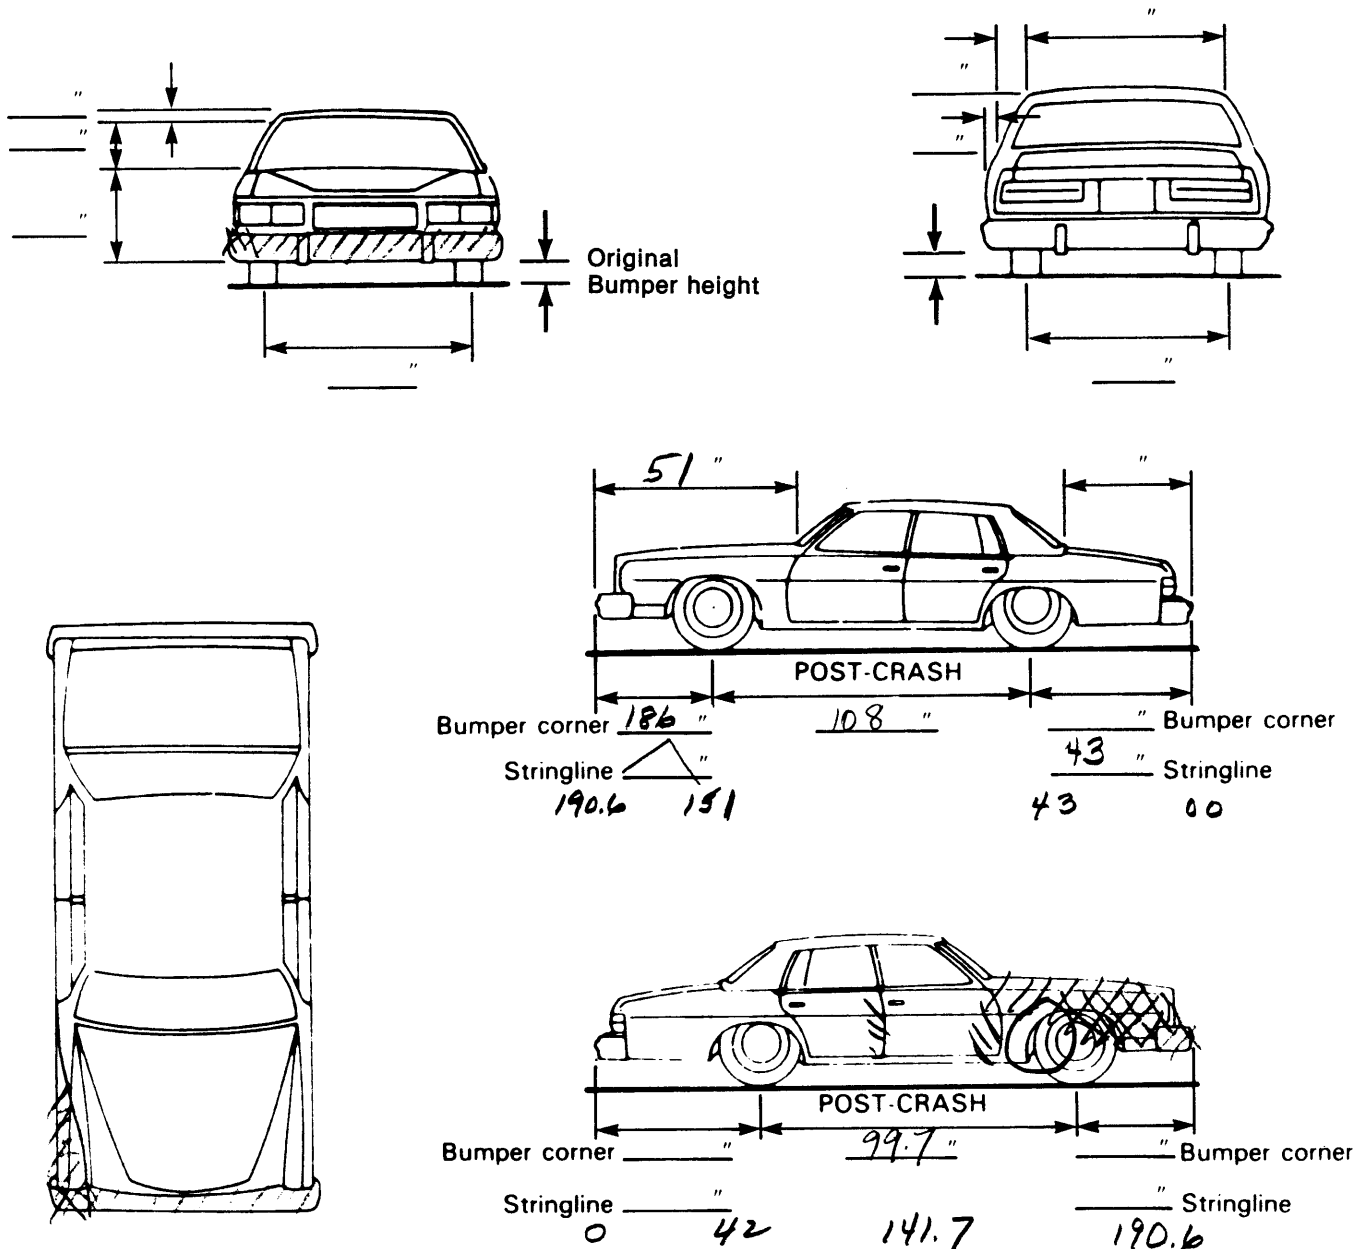
VEHICLE DAMAGE SKETCH

- 1989 Acura Legend 4 door coupe
- 12 o'clock right side-swiping type impact
- collision with 9" diameter wooden utility pole
- right front suspension driven 8" rearward

Specific Impact No.	Location of Direct Damage	Location of Field L	Location of Maximum Crush
1	Rt Front Corner	Full Front	C6
